**Optical Measurements
on Solid Specimens
of Solid Rocket Motor
Exhaust and Solid
Rocket Motor Slag**

George C. Marshall Space Flight Center
Marshall Space Flight Center, Alabama

TECHNICAL PAPER

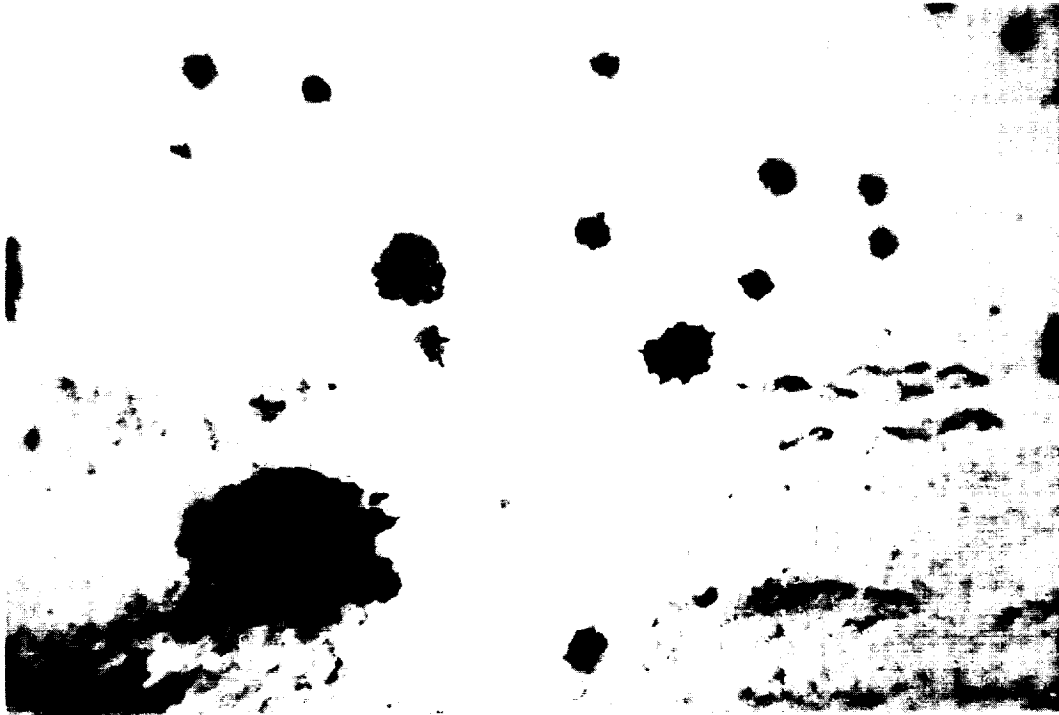
G. Subscale test motor specimen showing open side.

seen in the nozzle side (fig. 2E). The open side (fig. 2D) shows a speckled surface with regions of carbon entrapment. Figures 2G and 2H show enlargement of the carbon entrapment. Specifically figure 2H shows a region where the carbon has "wet" the alumina slag and surrounds a region of apparently glassy carbon.

The first range of reflectance at 40 to 50 percent correlates with the sample which was primarily in contact only with exhaust gases. This reflectance would seem to be applicable for clouds of particles and direct plumes from space motor exhaust. The figures 2G and 2H, however, indicate that there may be a direct carbon component present in the exhaust. This is supported by enlargement of the carbon entrapment, specifically (fig. 2H) the carbon has "wet" the alumina slag and is shown surrounding a region of glassy carbon trapped from the exhaust stream. Carbon in the flow stream is also supported by the presence at the end of the flow path of higher carbon concentrations as seen in the enlargement (fig. 2I) of the edge region (fig 2F). This suggests that there is a substantial amount of carbonaceous material in the flow stream which was noticed toward the end of the test motor deposited sample.
